2008

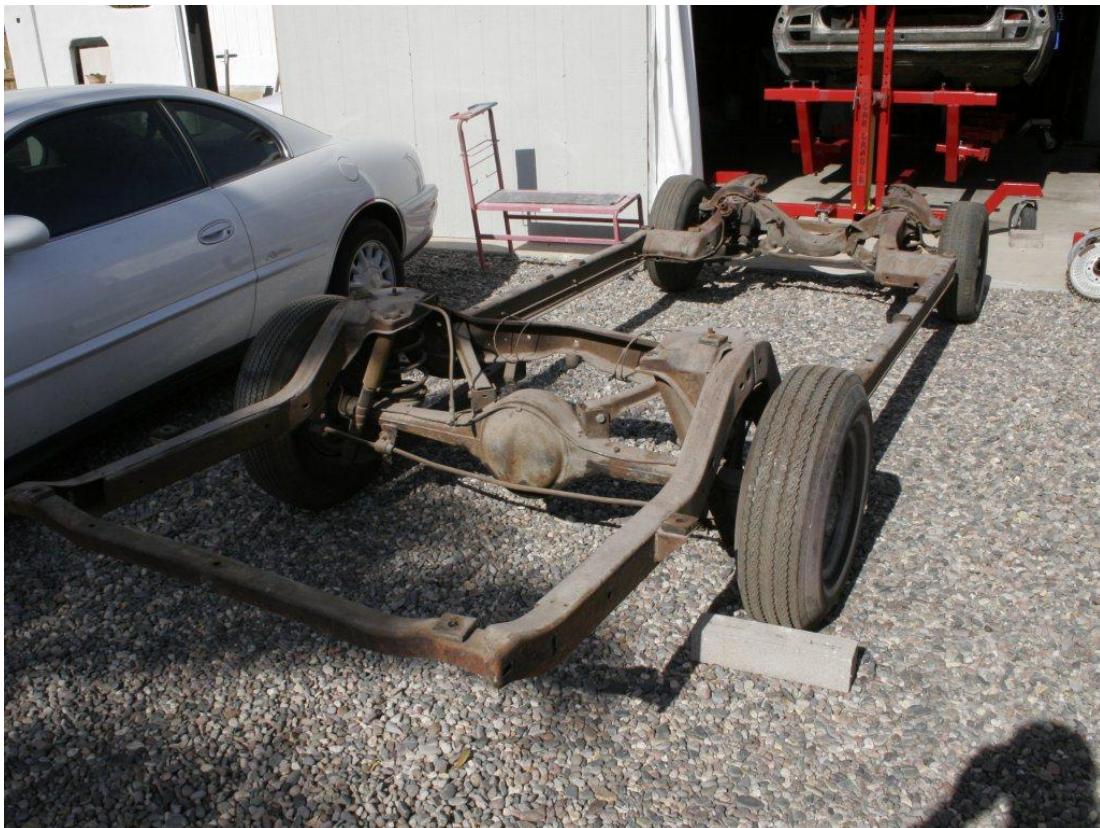
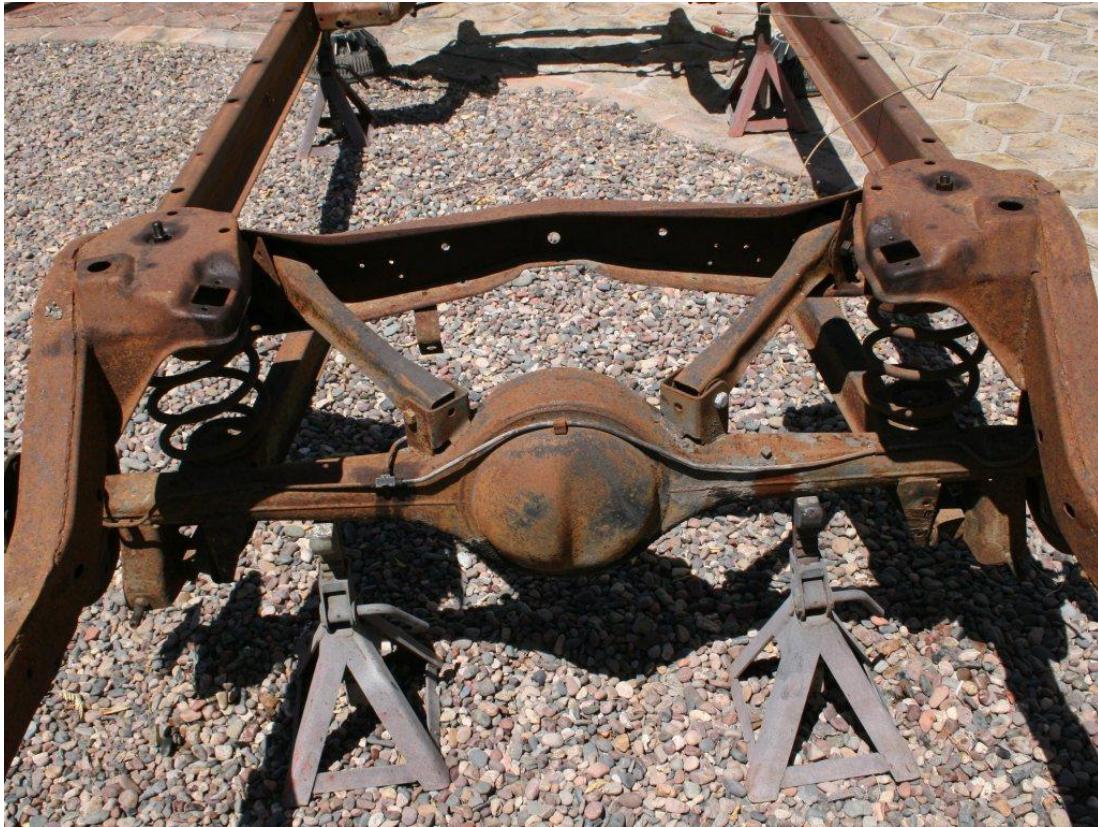
Frame before dissemble

The frame was stripped down and sent to be sand blasted. All the suspension parts were also blasted. Even though the body was in very poor condition from Midwest driving for several years, the frame was in very good condition and needed minor repairs. All of the control arms had new bushings and ball joints installed. New bolts were used to attach the suspension parts to the frame. New springs and shocks were installed and all new steering linkage. The power steering gear box was rebuilt by Lares Co and installed.

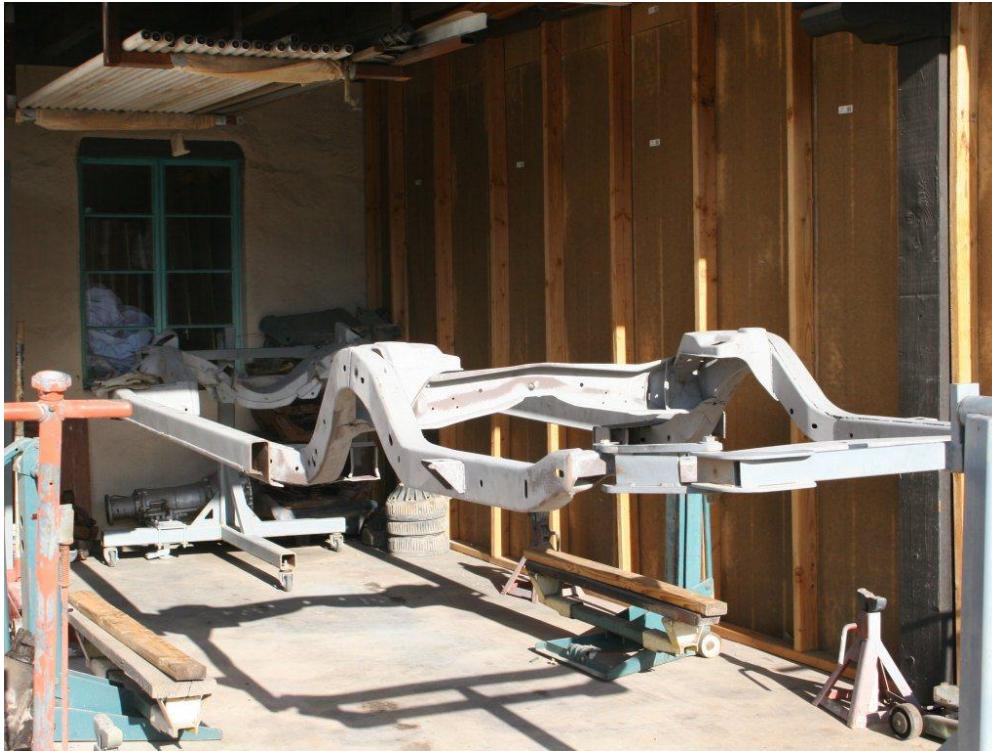
Frame after blasting and on rotator mounts for work and painting
